Central Place Design Guidelines

Central Place Historic District

Kirkwood Landmarks Commission

Date: June 2004

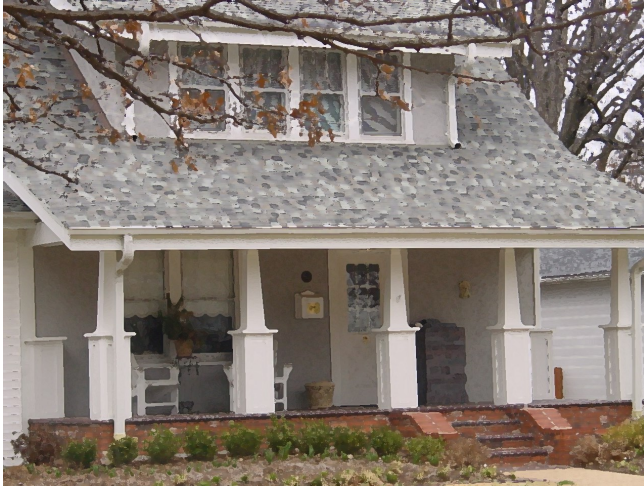
Porches are one of the most distinguishing features of the Craftsman Bungalow style. In addition to presenting a welcoming face to the street, the porch was seen as an outdoor room where the family could be closer to nature and visit with their neighbors. Spatially defined by low walls or balustrades and sheltered by extending the slope of the roof, most porches are full or half width. Since main floors are raised above grade a few feet, porches are accessed by a series of steps from the front walk which helps to emphasize the entry.

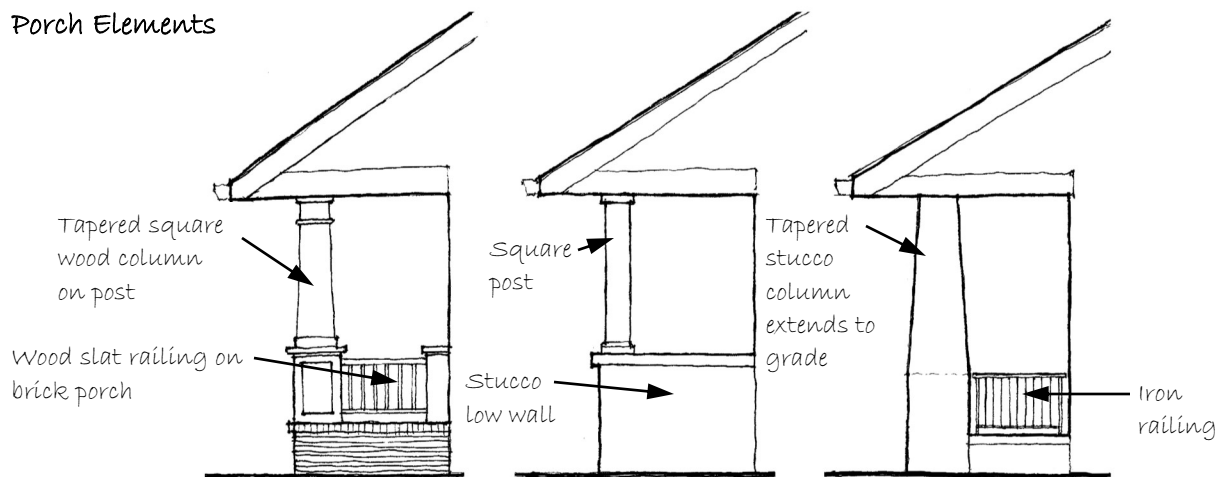
Porch Elements

The roof structure is supported by prominent, stout wood or stucco columns which may sit on solid piers. Some columns have slightly slanted vertical surfaces and many appear fatter than necessary; yet, this characteristic is a hallmark of the style.

- Constructing piers and solid low walls of materials that match the original house.
- Constructing open balustrades of simple square wood pickets, without elaborate turning profiles.
- Replacing or repairing damaged concrete steps, pier caps and copings with similar materials.

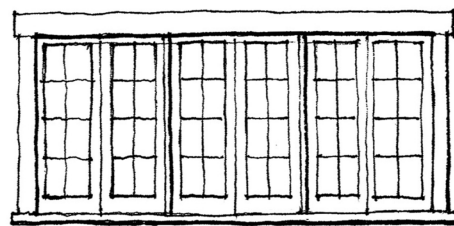
Ganged casements with casings

Windows are mostly double hung with glass light sash patterns of three over one, six over one and some six over six. In several cases, sunrooms and enclosed porches have casement style windows with Craftsman style muntin patterns.

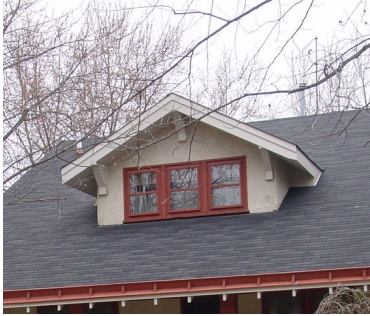
Due to the low building height typical of Bungalow style residences, dormers satisfied the functional need to increase ceiling clearance at upper floors and to admit natural light through dormer windows. Shed, gable and hip dormer roofs are most common.
